Scituate Wastewater Collection System Resilience Feasibility Study – Project Update Meeting

May 31, 2019

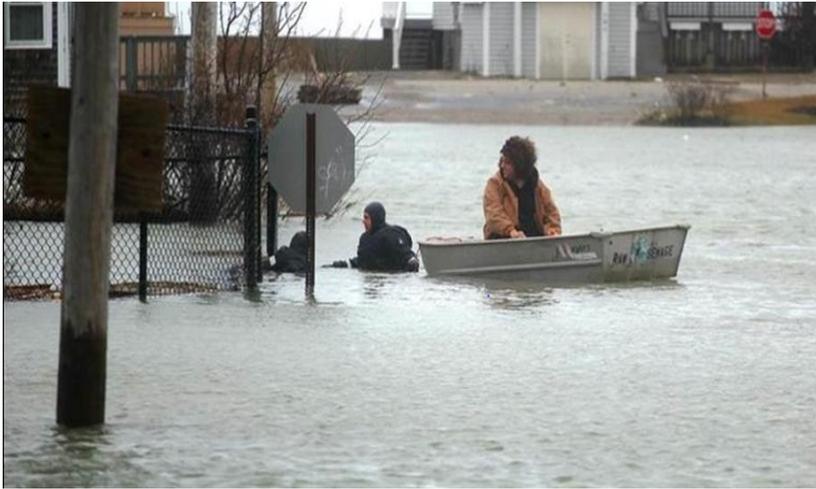
Sand Hills Pump Station March 1-3, 2018

1. Inflow/Infiltration (I/I) Coastal Storm Effects:

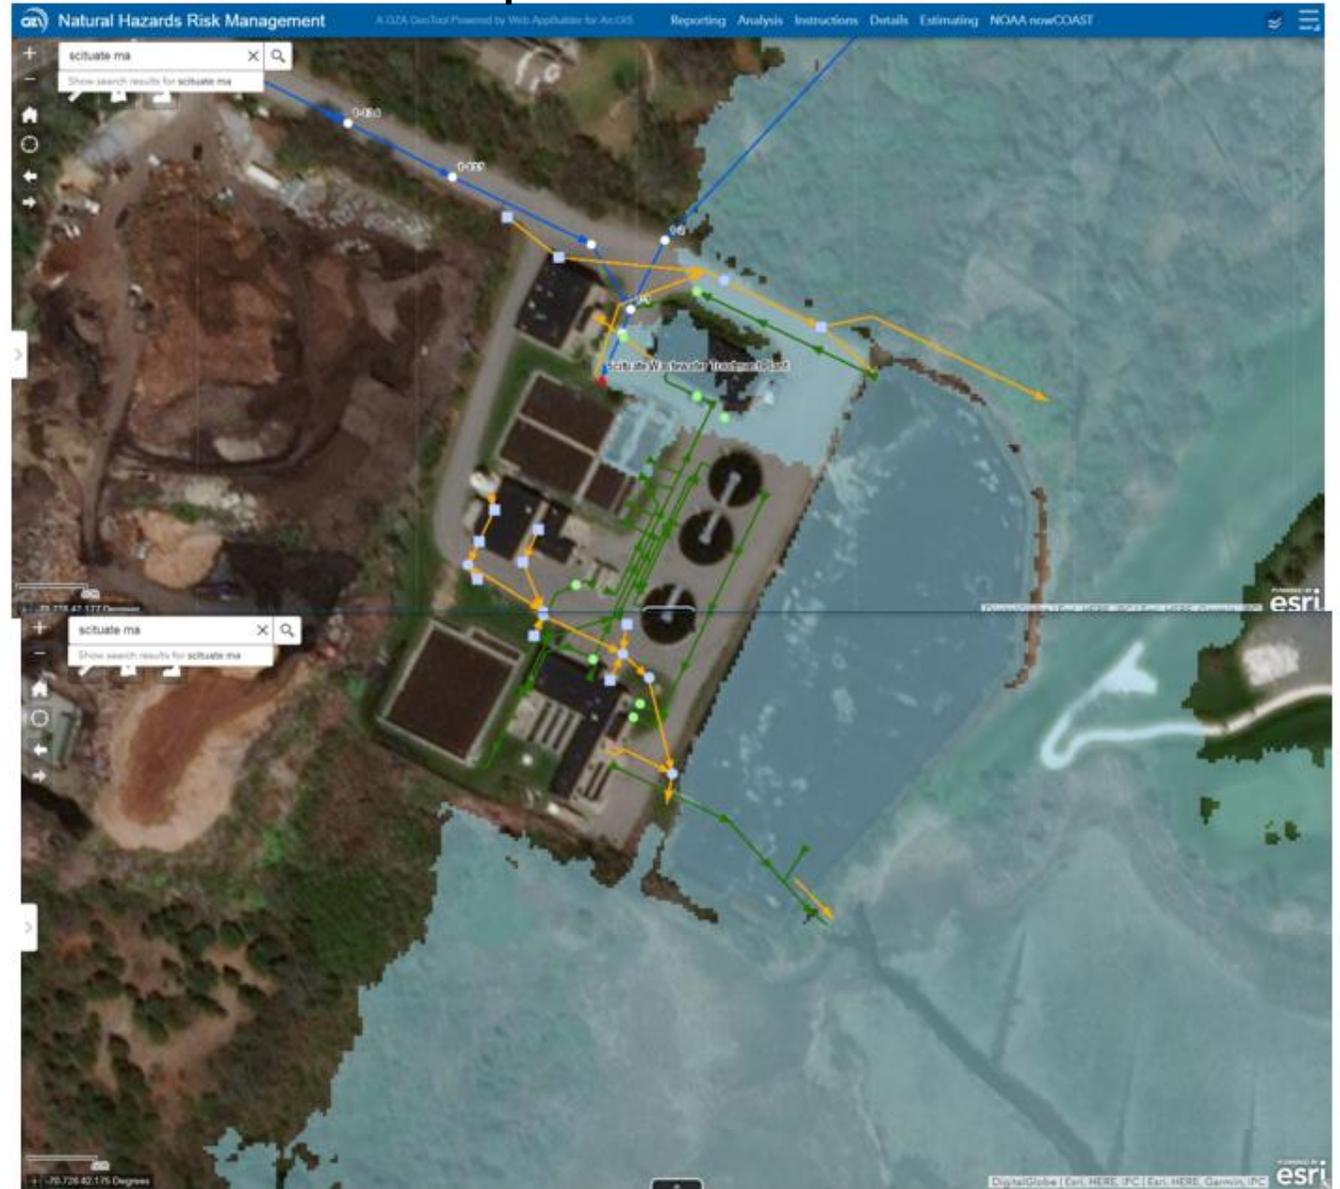
Flood Inundation (Floodwater = 11 feet NAVD88)

- Treatment Plant located within FEMA flood hazard areas (AE El 16 ft NAVD88)
- Ground surface +/- 11 to 15 feet NAVD88
- Impacts to plant start at flood water elevation +/- 10 feet (+/- 20 to 50 yr rec. int.)
- Significant impacts at flood water elevation +/- 12 feet (+/- 50 to 100 yr rec. int./with waves)
- Failure impacts at flood water elevation +/- 13 feet (+/- 100 yr rec. int./with waves)
- Hydraulic system flow capacity impacts - potentially starting at at flood water elevation +/- 10 feet (+/- 20 to 50 yr rec. int.)
